**321 Sample Dr
Example Report, FL 32828**

Date: August 11, 2115

File # H50855255

SUMMARIZATION OF REPAIRS

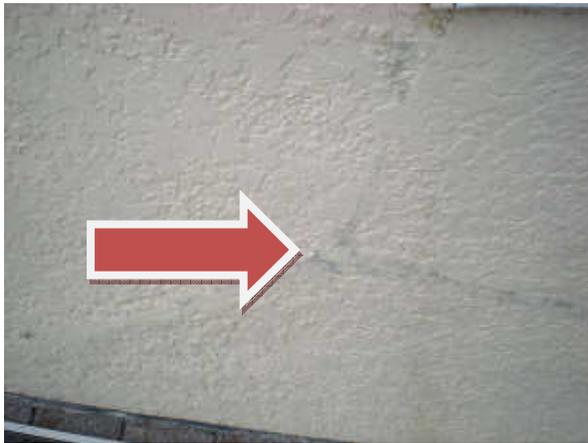
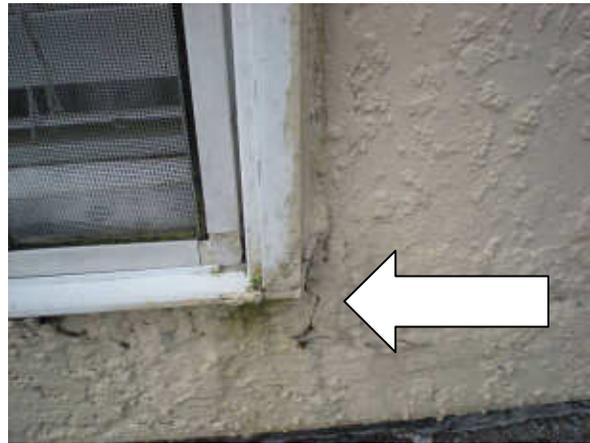
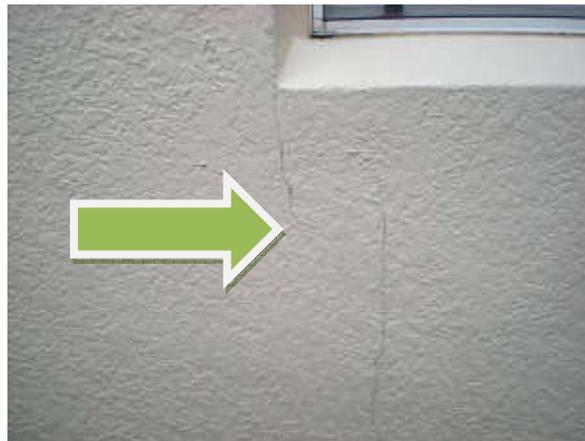
STRUCTURAL: Cracks in the wall, possibly from settlement, were noted around the home. Vegetation was in contact with the home at the left elevation. The top rail for the interior stair case appeared to be loose. Cracks in the wall, some that appear to have been previously repaired, were noted at the 2nd story back elevation; some of these areas appeared discolored were retaining moisture. Moisture in the wall was detected with a moisture meter at the back wall of the master bedroom which appears to be on the opposite side of some of the cracks listed above. Contact a licensed contractor to further evaluate the above items and make any needed repairs.

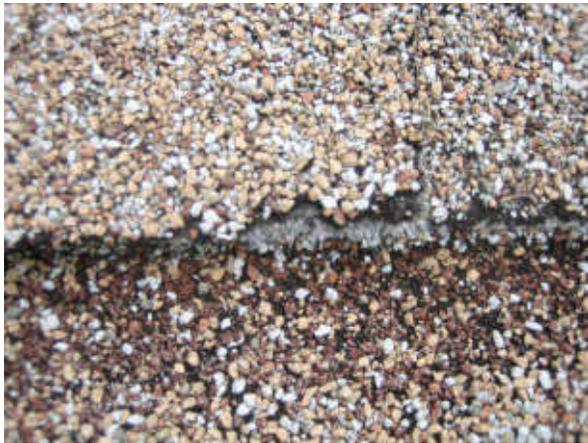
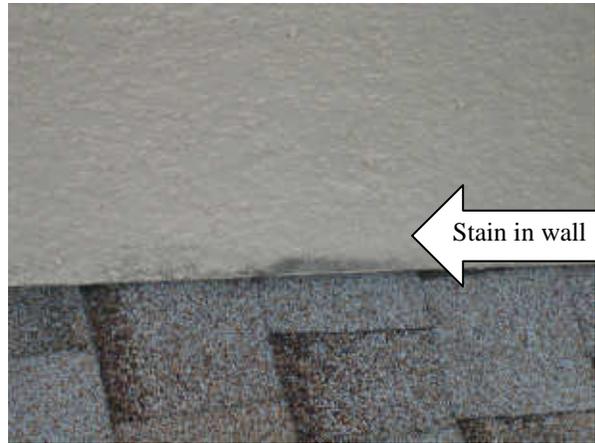
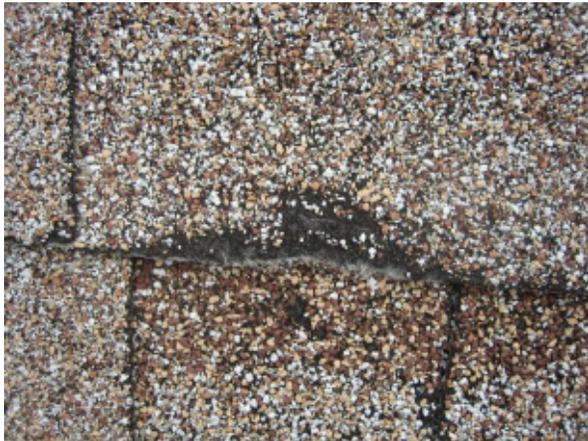
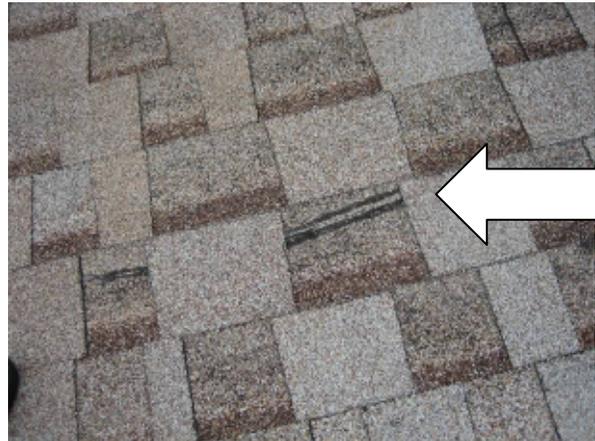
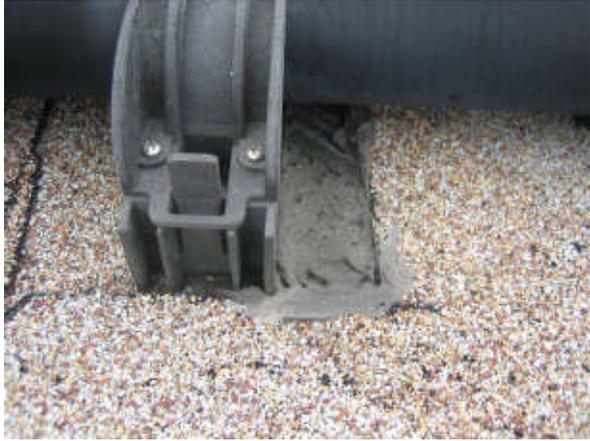
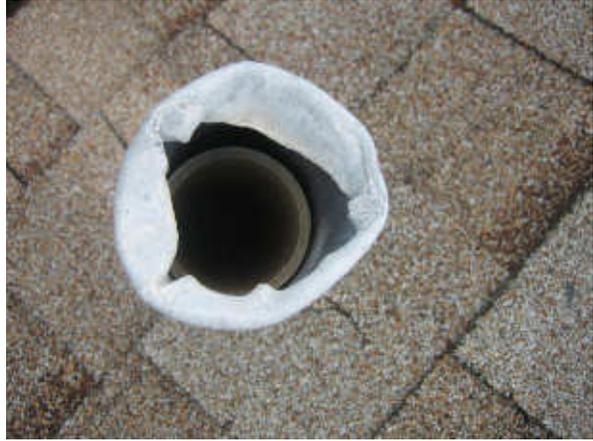
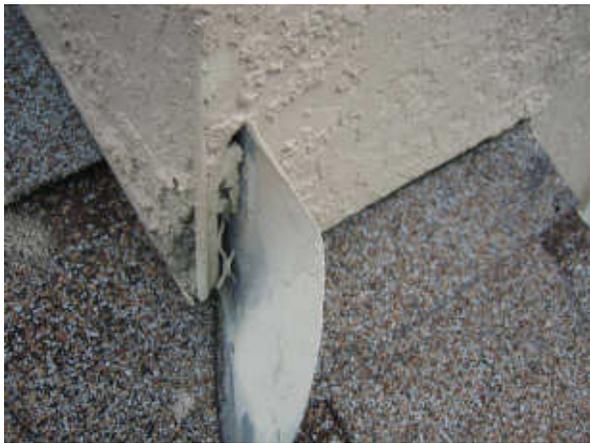
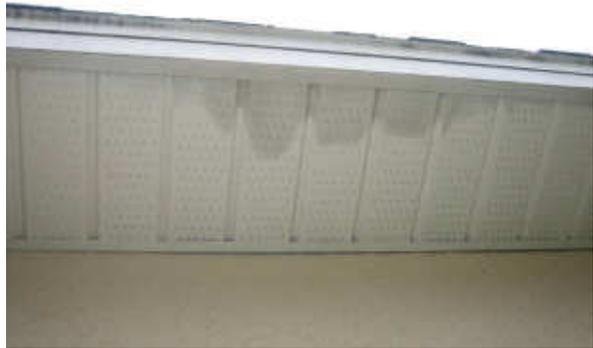
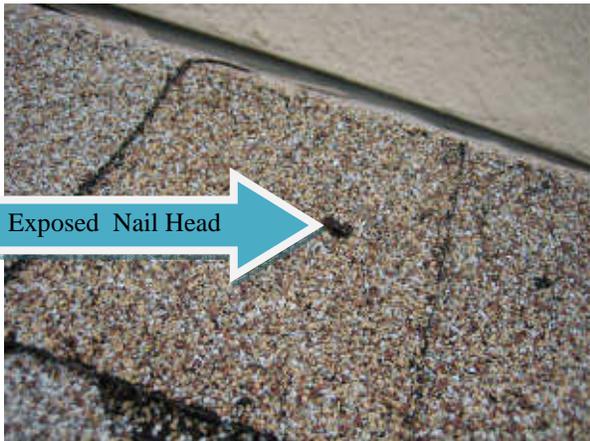
ROOF: Damaged off ridge vents were noted at the back slope and at the left slope of the roof over the garage. Staining in the wall was observed where the roof meets the wall at the left side of the front slope; a void in the stucco was discovered in this area as well. Worn and damaged shingles were noted around the roof, more so at the valleys and ridges. Missing shingles were noted at the far right slope near the solar pool heater. A ridge cap appears to have been cut at the ridge located at the front of the right slope where the solar heater is connected to the roof. Plumbing vents at the far left slope did not appear to have been sealed properly. A void in the stucco was noted where the wall comes in contact with the roof over the front entrance of the home. Vegetation was in contact with the roof at the front slope and at the roof over the front entrance. Staining was observed in the soffits around the home. Unsealed shingles and exposed screws and nails were noted in the roof over the front entrance. The roofing system should be further evaluated by a licensed roofing contractor, and needed repairs made.

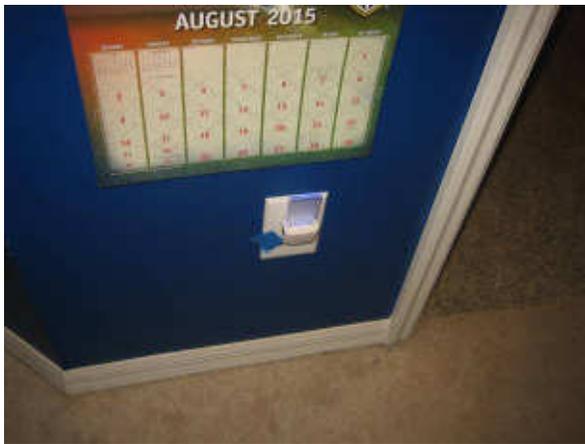
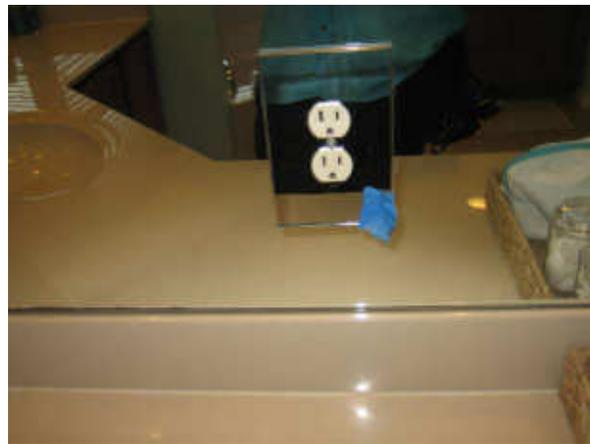
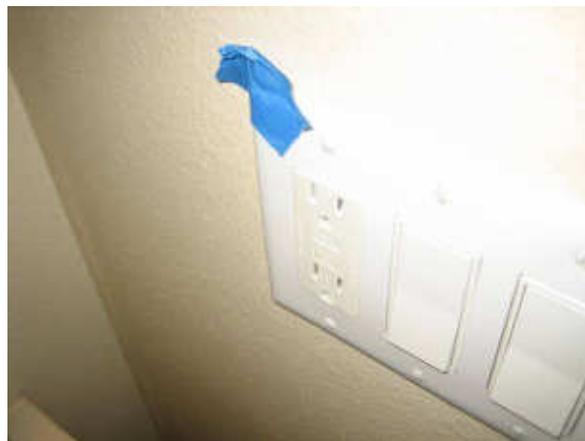
ELECTRICAL: A loose outlet cover was noted on an exterior outlet to the right of the garage; it was marked with blue tape. Loose outlets and/or outlet covers were noted around the home, they were marked with blue tape. The doorbell did not appear to be functional at the time of this inspection. A licensed electrical contractor should be contacted to further evaluate the entire electrical system and needed repairs made.

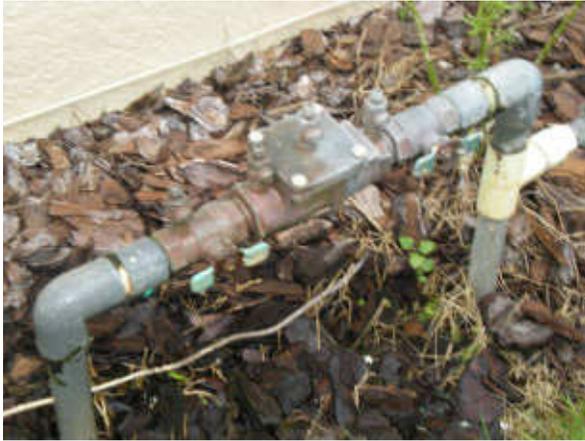
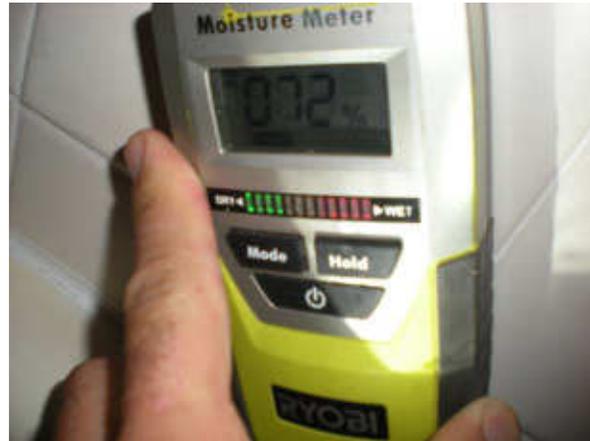
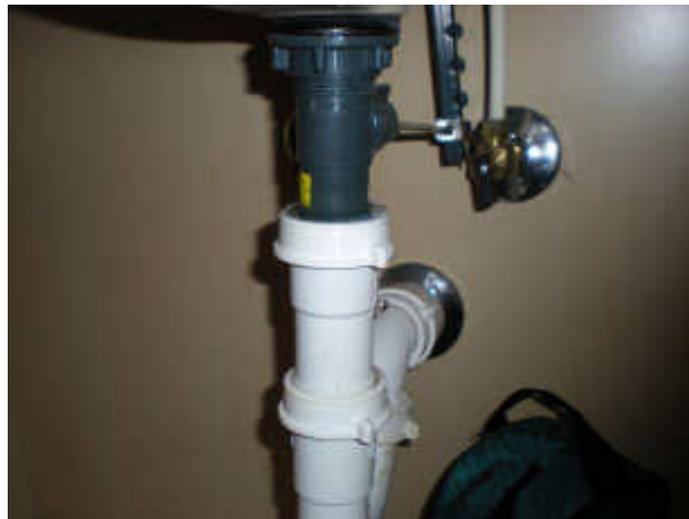
PLUMBING: Cracked grout and/or caulk and possible evidence of moisture intrusion was observed at the guest and master shower tiles; moisture was detected with a moisture meter. The stopper in the left master sink did not appear to be functioning properly. A leak at the back flow preventer for the irrigation system was discovered at the front of the right elevation. A leak was observed under the right upstairs bathroom sink; the faucet was also loose and the stopper was not functioning properly. A licensed plumber should be contacted to further evaluate the plumbing, and needed repairs made.

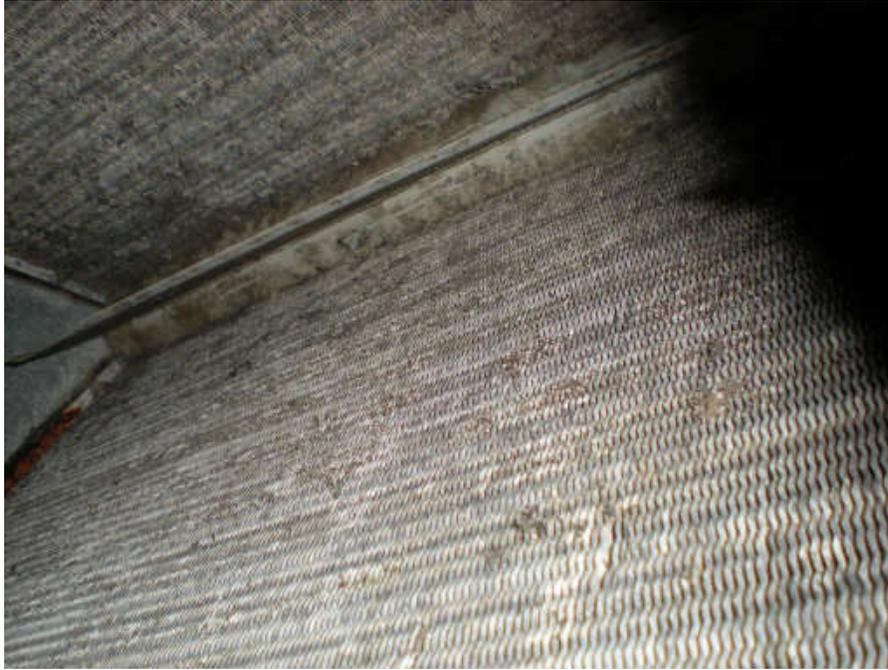
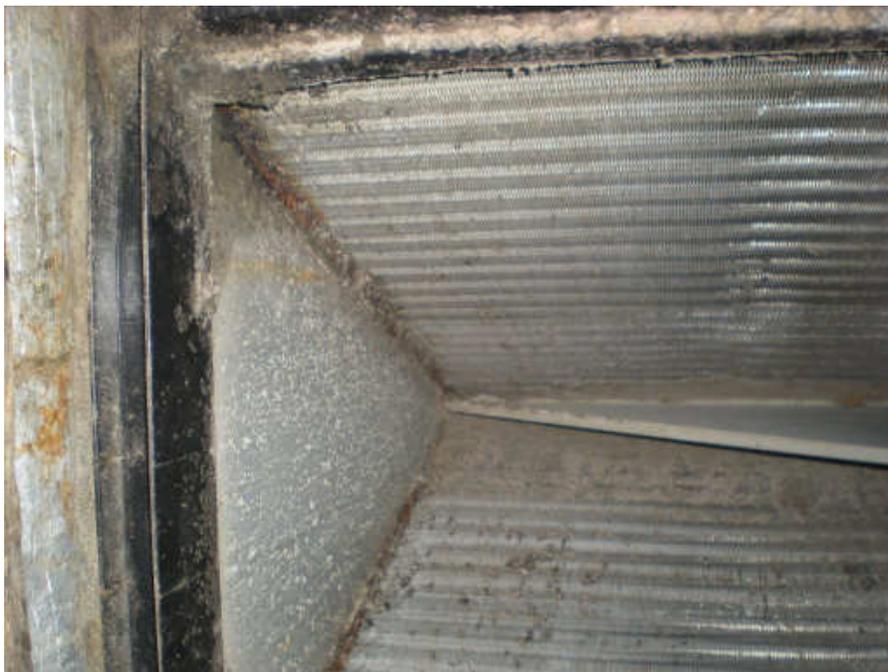
AIR CONDITIONING: The coils in the upstairs air handler were somewhat dirty and rusted. The coils in the downstairs air handler appeared to be more dirty. The upstairs air handler was not functioning properly although it appeared to be due to the float switch. The Heating and air conditioning system should be further evaluated by a licensed contractor and needed repairs made.

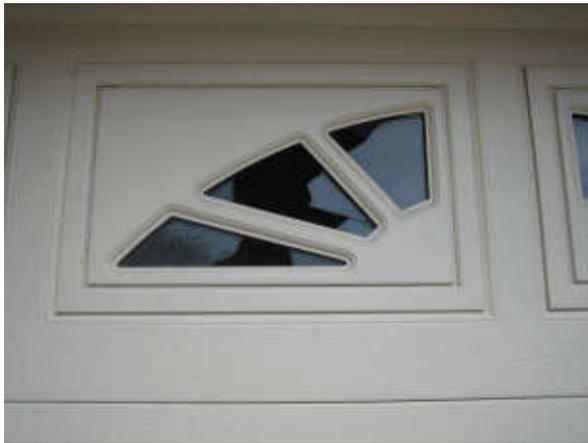
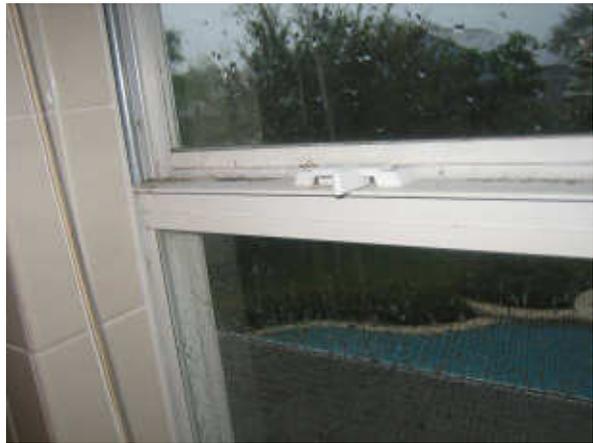
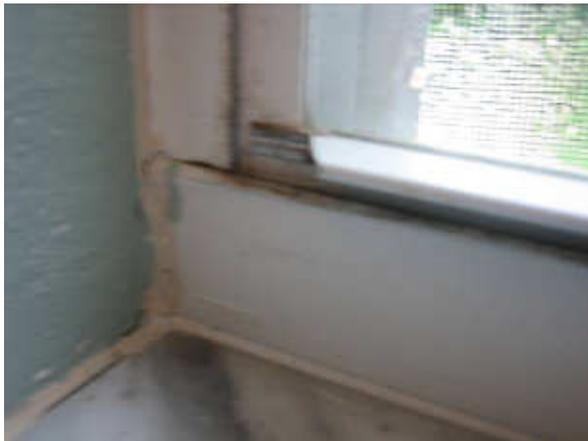
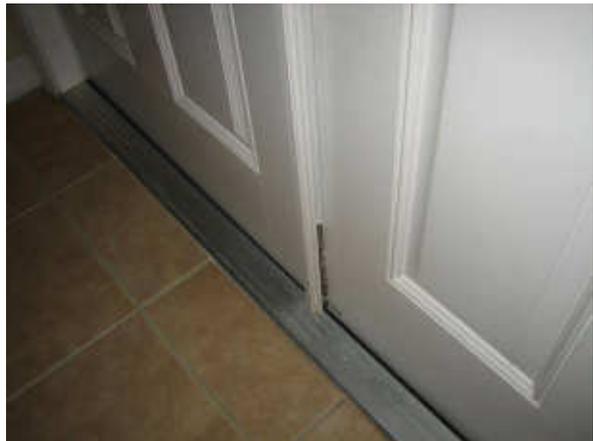
DOORS & WINDOWS: Damage was noted to the weather strip at the front entrance door. The upstairs windows were not opening and closing easily. Missing window screens were noted. Evidence of possible moisture intrusion was noted in the upstairs windows as well as the downstairs guest bathroom window. A window lock in the far left upstairs guest bedroom was not functioning properly; it was marked with blue tape. The back right sliding glass door was not functioning properly. The deadbolt for the interior garage door was not functioning properly. The reverse safety systems for the garage door did not appear to be functional at the time of this inspection; this is a safety hazard. Some damage to the bottom of the garage door was noted. Broken glass was discovered at the top of the garage door. Contact a licensed contractor to further evaluate the above items and make any needed repairs.

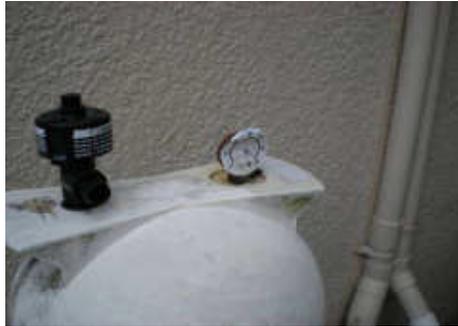
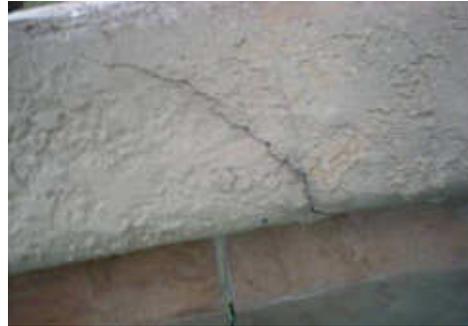
The pump did not appear to be grounded. Damage was noted at a hose bibb handle at the pump. Cracks were noted around the pool deck. Damaged gauges were discovered at the pump. A salt generator was disconnected. A leak in the solar heater water line was noted at the left elevation near the roof. A floating feeder in the pool could be a possible sign that the chlorinator in the main line is not functioning properly. What appeared to be an excessive amount of air was noted in the sight glass. There was not a pool safety fence or alarm present. A detached deck drain cover was noted. A licensed pool company should be contacted to further evaluate the pool system and needed repairs made.

SWIMMING POOL: The pump did not appear to be grounded. Damage was noted at a hose bibb handle at the pump. Cracks were noted around the pool deck. Damaged gauges were discovered at the pump. A salt generator was disconnected. A leak in the solar heater water line was noted at the left elevation near the roof. A floating feeder in the pool could be a possible sign that the chlorinator in the main line is not functioning properly. What appeared to be an excessive amount of air was noted in the sight glass. There was not a pool safety fence or alarm present. A detached deck drain cover was noted. A licensed pool company should be contacted to further evaluate the pool system and needed repairs made.
